Spot Safety Project Evaluation

Spot Safety Project # 04-95-271

Spot Safety Project Evaluation, of the Traffic Signal Installation and Commercial Channelization, At the Intersection of NC 111 and SR 1754-Zion Church Road near Seven Springs, Wayne County

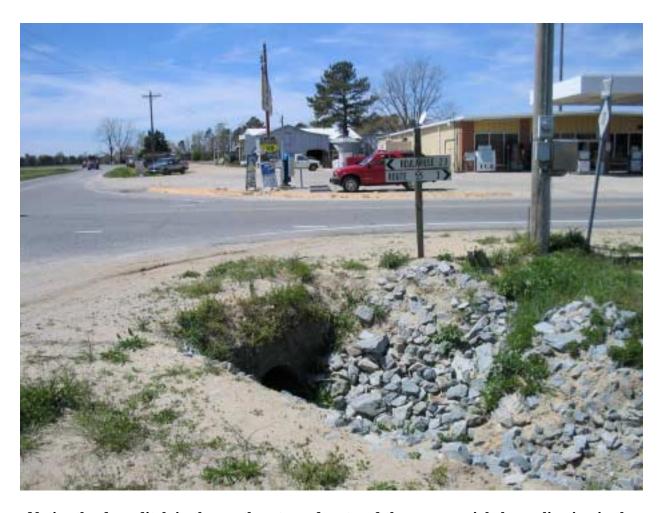
Notice the deep ditch in the northeast quadrant and the commercial channelization in the northwest quadrant of the intersection.

Please see the attached *Treatment Site Location Photos*. Photos are provided for each leg of the treatment intersection. Also, a photo is attached which shows the deep ditch located in the northwest quadrant of the intersection. The deep ditch is a potential hazard to any run-off-road vehicles. The commercial channelization in the northwest quadrant, added as part of the spot safety project, is also depicted in this photo.
